Ball Mill Trunnion Processing Factory---CHAENG

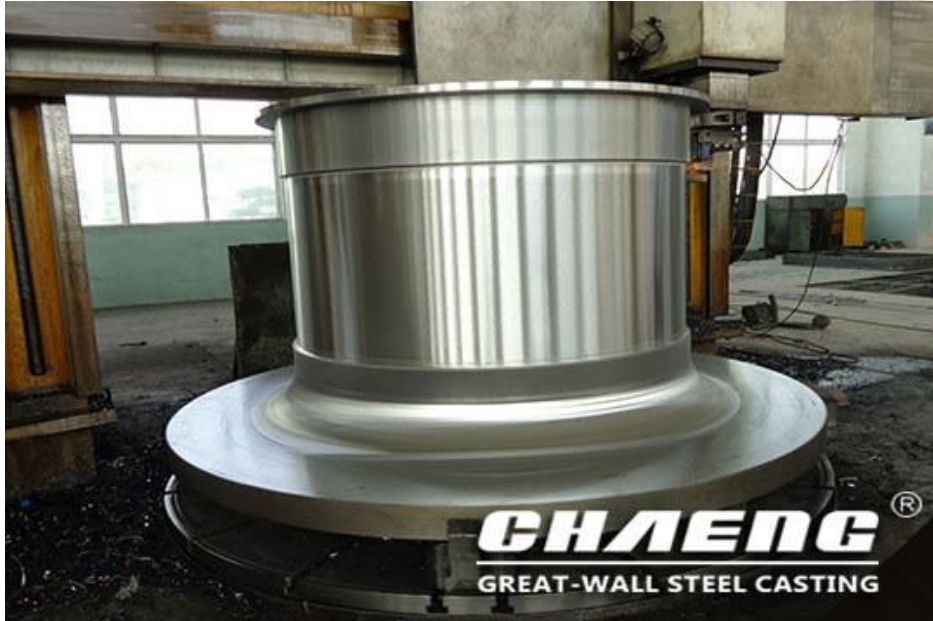
1. The ellipticity error of the trunnion journal is too large or the cylindricity error is too large, and the surface has deep dents, so that cracks or holes appear.

2. The trunnion is axially cracked, and the crack extends from the center position to the both ends in the axial direction, and penetrates the trunnion wall in a serious case. Usually, the crack is not perpendicular to the center, but an irregular diagonal line.

3. The inner hole of the trunnion is seriously worn, the diameter of the inner hole becomes large, and the maximum wear amount is more than 50%.

After long-term operation of the trunnion, the wear of the trunnion will naturally occur due to material fatigue, but occasional poor maintenance will also increase the wear of the trunnion. If a small amount of material enters between the inner bore of the trunnion and the spiral barrel at the feed end, it will cause serious wear of the inner hole of the trunnion. Wear to a certain extent, if not found and repaired in time, it will cause cracks, holes, etc., affecting the continuous operation of the ball mill, must be repaired.

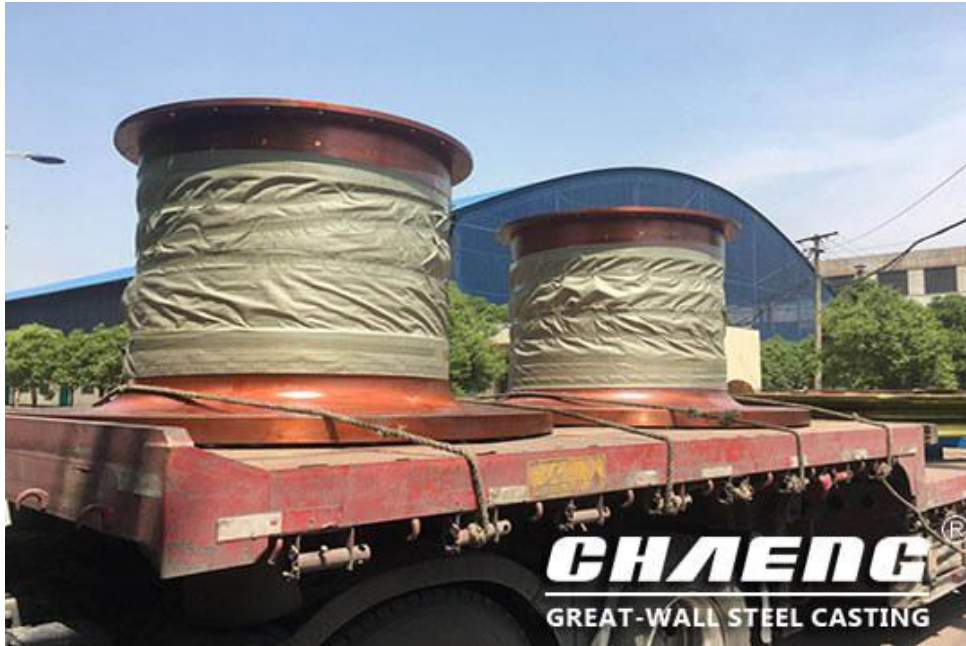
CHAENG uses a unique heat treatment technology to improve the hardness of the trunnion and enhance the impact resistance;

The trunnion produced by CHAENG is cast from high-strength steel. In the early stage of casting, the engineer of CHAENG also optimized the structure of the trunnion for the running characteristics of the ball mill, which greatly guaranteed the long-term operation of the part. Lower stability, extending the life of the components; CHAENG has strong production capacity of steel castings, which can produce large quantities of trunnion and other components with short casting cycle and large output.
